# Dealing With Condensation, Dampness and Mould

This document will help you to identify different condensation and dampness problems and to develop and implement appropriate technical solutions.

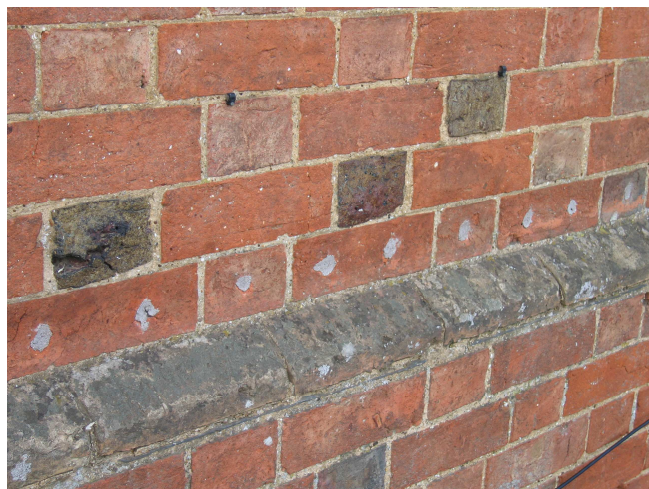
A brick wall that has had an injected damp proof course installed

Where a damp proof course is absent, the usual solution is to inject a new damp proof course into the existing wall. Holes are drilled at regular intervals around the perimeter of the building, just above external ground level, and a chemical is injected under pressure. The chemical is absorbed into the masonry and forms an effective barrier to the passage of moisture.

Injected damp proof courses must be installed by specialist contractors, who usually supply a guarantee. Prior to installation, it is necessary to remove any internal plaster finishes from all affected walls up to one metre above the internal ground floor level. Once the damp proof course has been injected, you can replace the plaster with new, waterproof plaster and replace or make good any skirtings, etc.

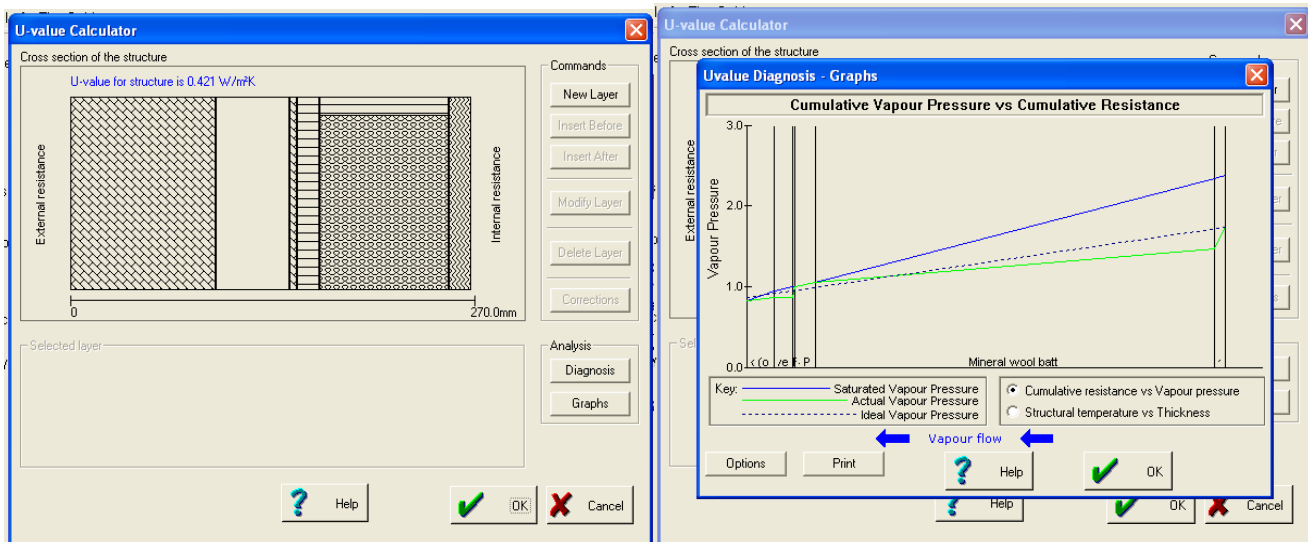
Cross-sectional graph through a timber-framed wall construction showing actual and saturated vapour pressures within the wall, in order to indicate the risk of interstitial condensation (condensation is likely where Saturated Vapour Pressure  $\geq$  Actual Vapour Pressure, ie where the green line meets the blue line).<sup>1</sup>

The illustrations below, from the NHER evaluator programme, show analysis of a poorly insulated, brick-clad, timber framed construction in which there is a risk of interstitial condensation on the inner surface of the plywood sheathing.

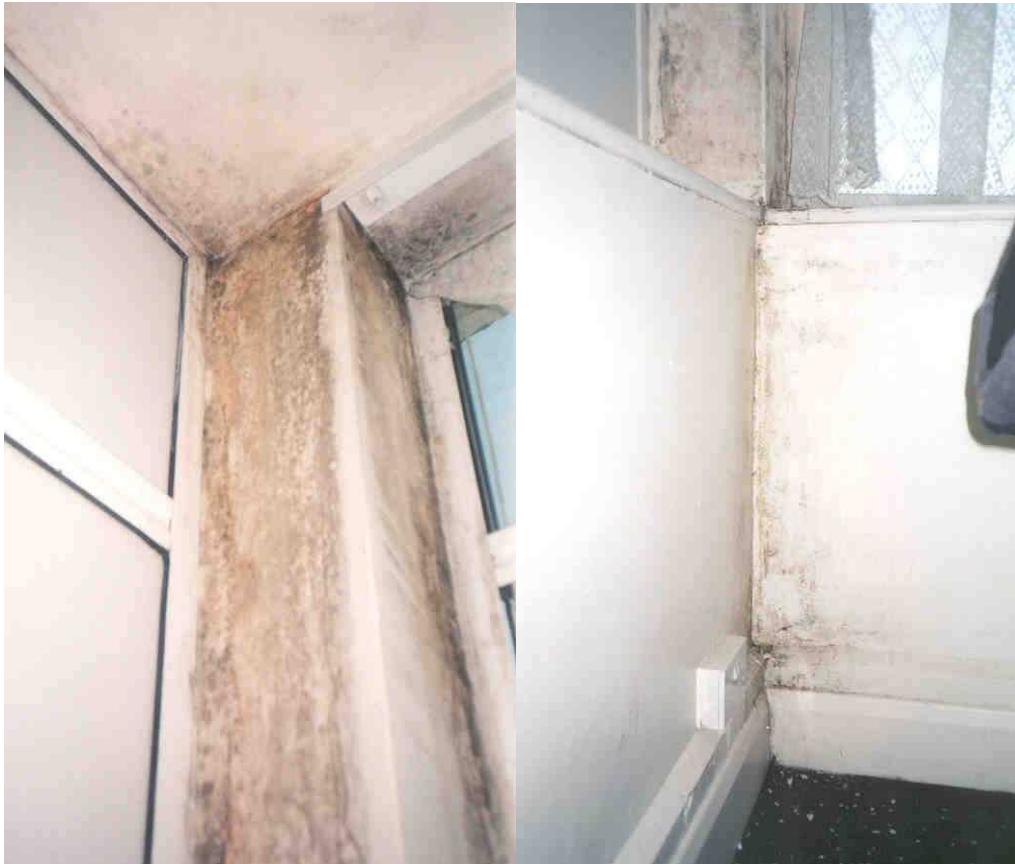
Dampness and mould staining due to condensation arising from thermal bridging in a building where the structural concrete frame bridges the wall insulation

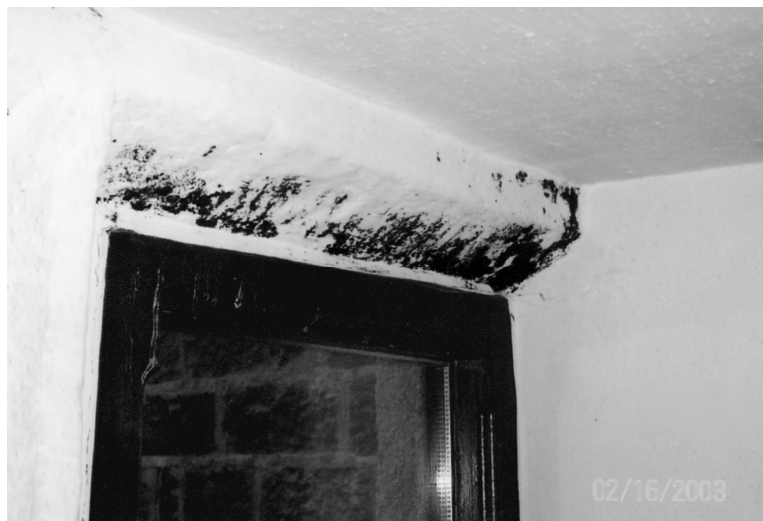
Dampness and mould staining due to a combination of surface condensation and thermal bridging in an under-heated dwelling.  
(Picture courtesy of Energy Inform)

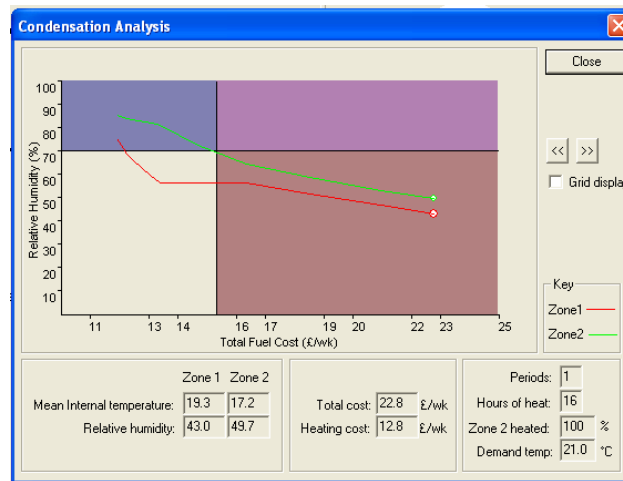
Surface condensation risk analysis for a poorly insulated dwelling with inefficient heating and no ventilation.<sup>1</sup>

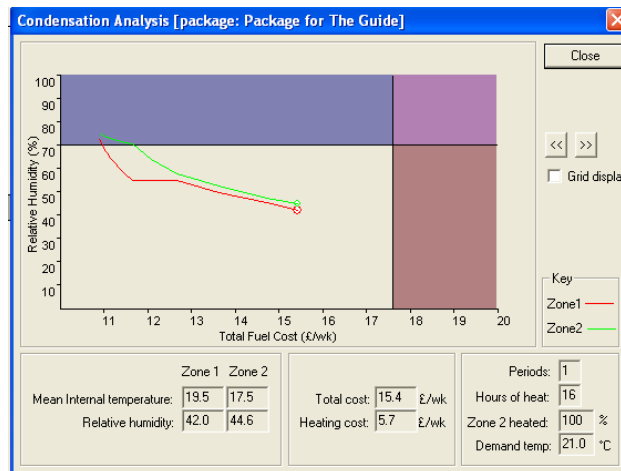
Surface condensation risk analysis for the same dwelling, after a package of improvements has been implemented

The following chart shows another analysis for the same property after a package of improvements (wall insulation, a more efficient heating boiler and controlled ventilation) has been installed. There are now several affordable heating patterns, which do not carry a risk of surface condensation.
